DVGI 2024-25 GEOTECHNICAL PROJECT OF THE YEAR

Submitting Company:	Peirce Engineering, Inc.
Submitting Person(s):	Jennifer Peirce Brandt, P.E.
Project Name:	Roberts Children's Health at Children's Hospital of Philadelphia
Owners:	Children's Hospital of Philadelphia Philadelphia, PA
Contractor:	JPC Group, Inc., Blackwood, NJ LFDPR, JV
Geo-Structural Engineer:	Peirce Engineering, Inc., Phoenixville, PA

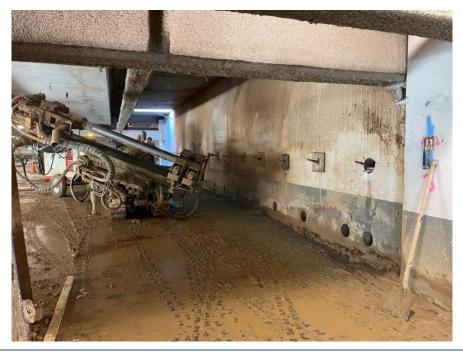
Figure 2: Low overhead clearance inside the existing Osler Garage.

- Planning and coordination were critical for work within proximity of acute care medical and research facilities and critical infrastructure.
- Low clearance and restricted working conditions due to limited structural capacity of the existing floor slabs required the use of small drilling equipment in the Osler Garage structure.
- Construction methods in the dense urban environment required alternative means and methods to mitigate noise and vibration impacts.
- Noise and vibration monitoring are critical near hospitals and research facilities.

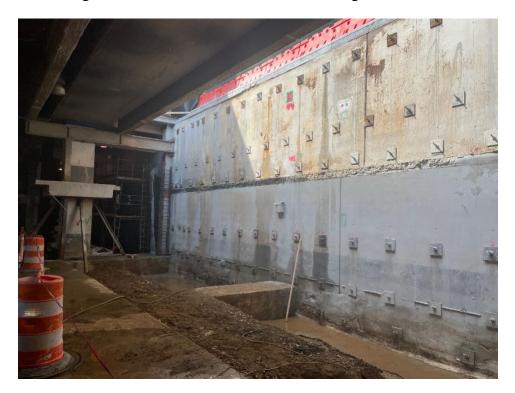
Figure 3: Osler Garage foundation wall soil nailed with existing floor slab removed.

The biggest challenges for the design were the congested city location surrounded by medical buildings, the unknown geotechnical conditions, and the adjacent research buildings and potential noise & vibration impacts. The proposed work was installed from inside the existing parking garage and within the limits of previous building excavations with ground anchors to be installed in unknown fill material. The possibility of encountering abandoned excavation support was a concern. The presence of both the existing garage foundation walls and bedrock above subgrade was a challenge in designing the temporary soil nails and concrete soldier beams. Due to neighbor access agreements and the proposed patient tower footprint, there was no space to accommodate a traditional support system, therefore a soil nail system incorporating the existing foundation walls was selected.

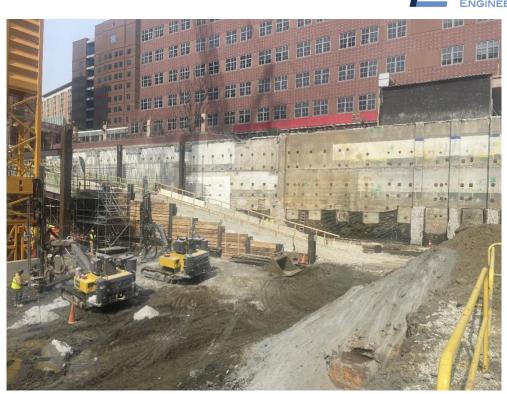
Figure 4: North view of existing foundation wall with floor and roof slabs removed, concrete soldier beams, rock excavation, and temporary SOE construction access ramp. Proximity of adjacent Research Facility and actual work area.

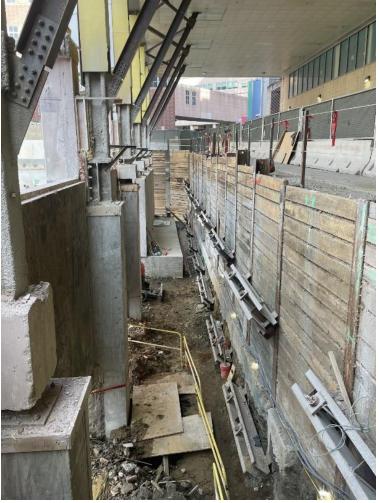
Figure 5: East Service Drive support of excavation in low overhead conditions required steep tieback anchors to clear CHOP Main Hospital basement foundations.
